**Urgent Field Safety Notice - Cover letter for  
EMBLEM™ Subcutaneous Implantable Cardioverter Defibrillators (S-ICDs)  
(Models A209 and A219)  
EMBLEM™ S-ICD Subcutaneous Electrode (Model 3501)**

**Subject: Important Medical Device Advisory Update to August 2019 Advisory**

## Urgent Field Safety Notice

**Subject: Important Medical Device Advisory - EMBLEM™ S-ICD Subcutaneous Electrode (Model 3501) with a potential for electrode body fracture (Boston Scientific Field Action Reference: 92384167-FA).**

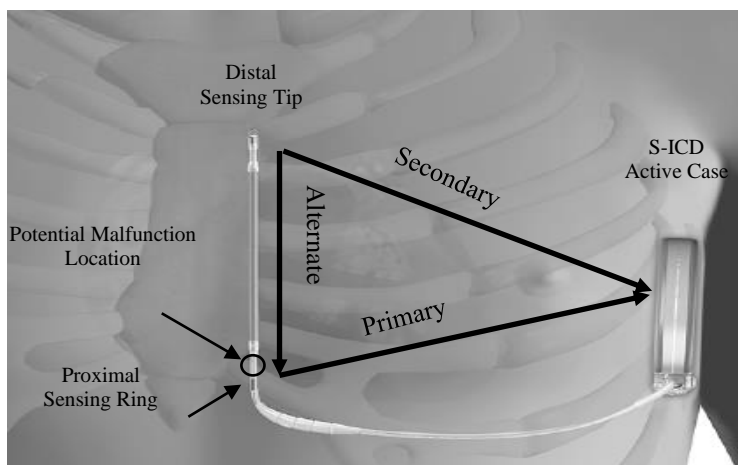
During assembly of the EMBLEM S-ICD Subcutaneous Electrode, a small amount of adhesive is applied to a location just distal to the proximal sense ring. Over time, mechanical stresses on the electrode body at this location may create the potential for a fatigue crack to initiate from the outer lumen. This crack then propagates inward toward the center-oriented distal sense conductor, eventually resulting in a fracture of the two high voltage conductors. To date, Boston Scientific has received 27 reports of electrode body fractures at this location; refer to Figure 1 for an image of the S-ICD system *in vivo*, note the potential fracture location with respect to the programmable sensing configurations (i.e., Primary, Secondary or Alternate).

**Figure 1. S-ICD System *in vivo* depicting programmable sensing configurations and the potential malfunction location.**

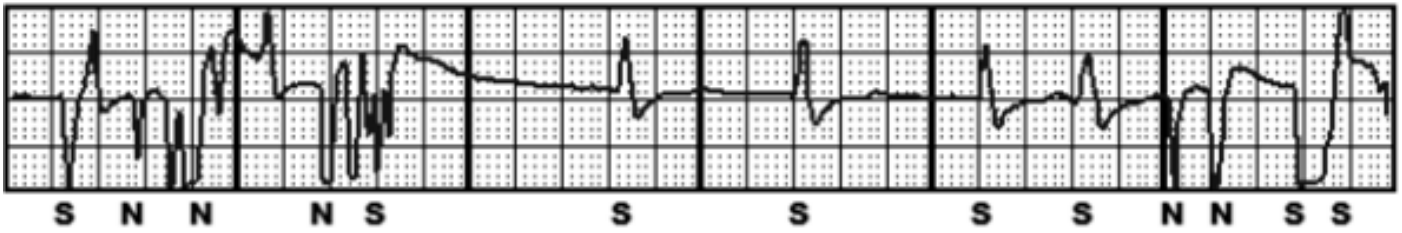
Manifestation of this fracture can be detected in two ways: non-physiologic mechanical artifacts and/or the presence of a high impedance alert condition. The method of detection, as well as timing of detection, are dependent on programmed sensing configuration and progression of conductor fractures. A distal sense conductor fracture may be detected via non-physiologic, mechanical artifact precursors (see Figure 2) stored in episode electrograms (S-ECGs) within systems programmed to Secondary or Alternate sensing configurations. These precursor artifact signals may also result in an inappropriate shock. S-ICD systems programmed to an Alternate or Secondary sense configuration have exhibited precursor artifact signals as early as two months before the fatigue crack propagates to the high voltage conductors. If both high voltage conductors fracture, shock therapy will be unavailable.

**Figure 2. Example of non-physiologic, mechanical artifact; precursor artifact signals span one or both amplitude limits of the S-ECG.**
